**SUBJECT: EXPLORATORY TEST PIT REPORT – Jewett White Lead Company,  
Staten Island, Richmond County, New York**

## EXPLORATORY TEST PIT REPORT

**SITE NAME:** Jewett White Lead Company  
DCN #: RST2-02-F-0797  
TDD#: TO-0009-0126

**ACTIVITY DATES:** December 17 -18, 2008

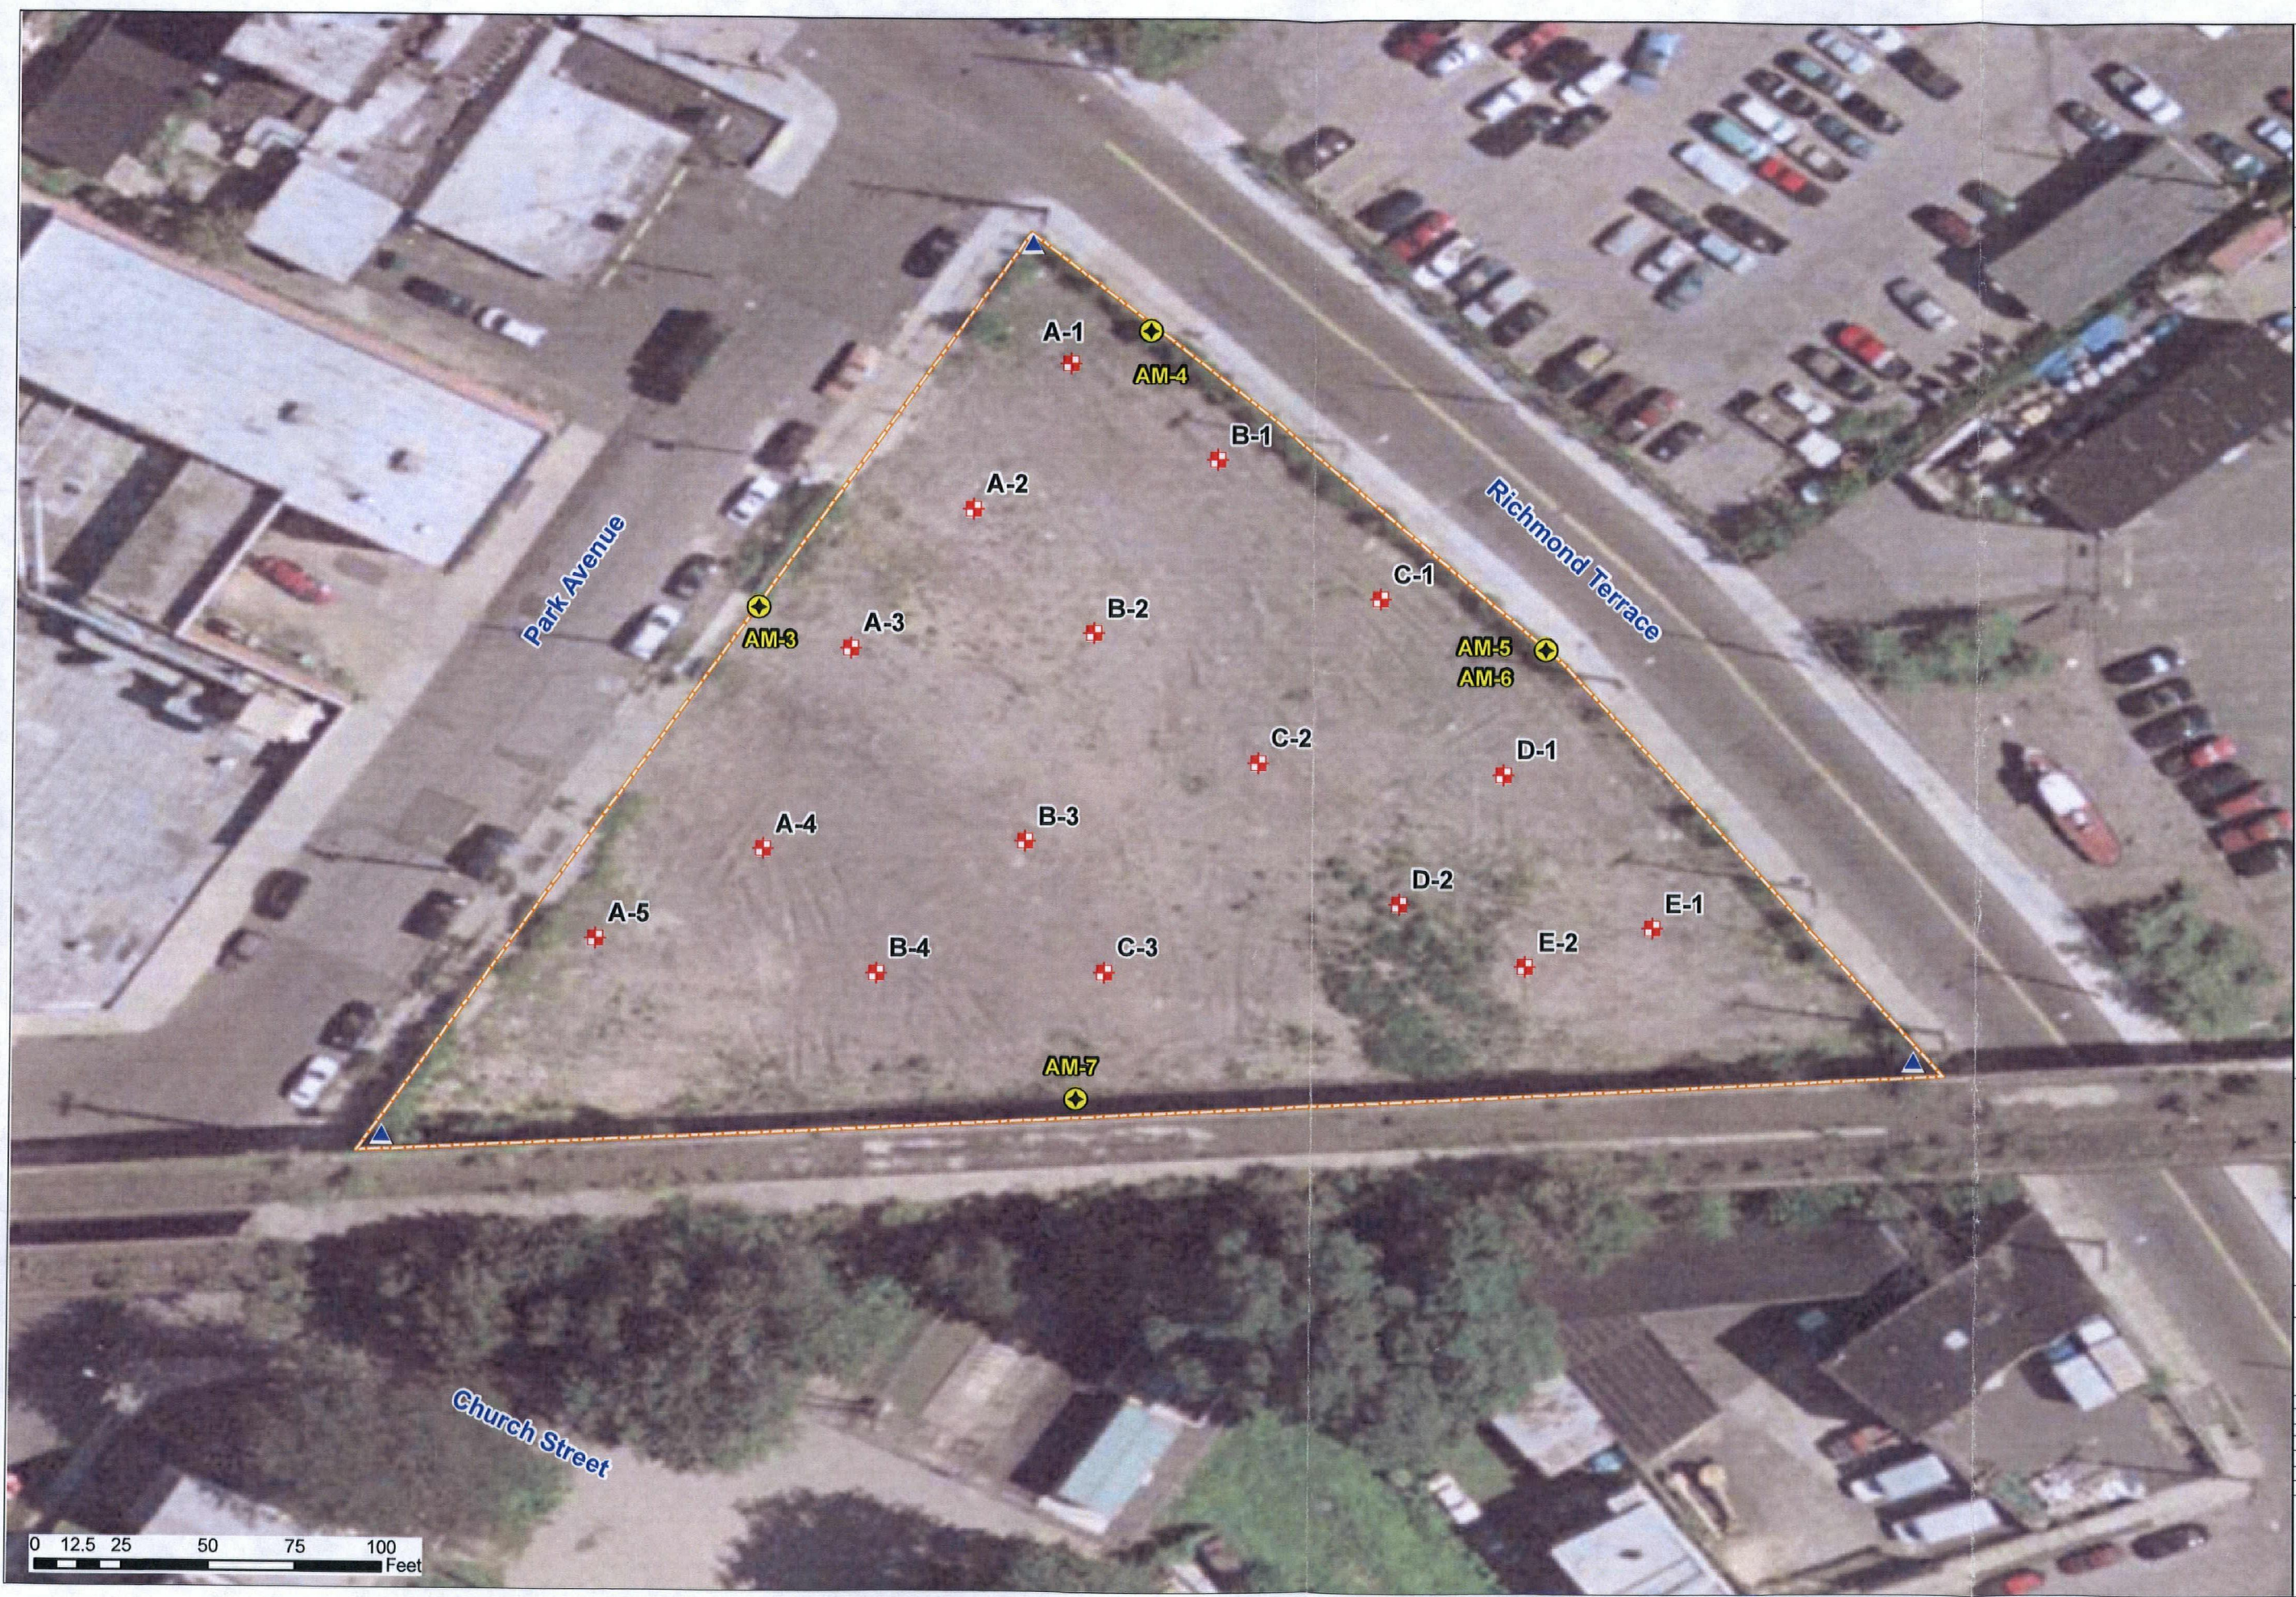
**Figure 1:**  
**Test Pit Location Map**

1. **Site Location:** 2000 Richmond Terrace  
Staten Island, Richmond County, New York  
Refer to Figure 1, Attachment A for the Test Pit Location Map and Attachment B, Table 2, for the Site Locational Data
2. **Test Pit Installation:** RST 2 provided a backhoe to install sixteen (16) test pits to a depth of approximately four feet below grade at locations as shown in Figure 1, Attachment A. The subcontractor, Marcor Remediation, set up a decontamination area consisting of a framework of 2 X 4 lumber lined with polyethylene plastic, as shown in Picture 1, Attachment D. A typical test pit operation is shown in Picture 2, Attachment D. The backhoe was decontaminated after every test pit and wash water was collected in drums. The backhoe was also decontaminated before leaving the site. In total, two 55-gallon drums of wash water were collected.

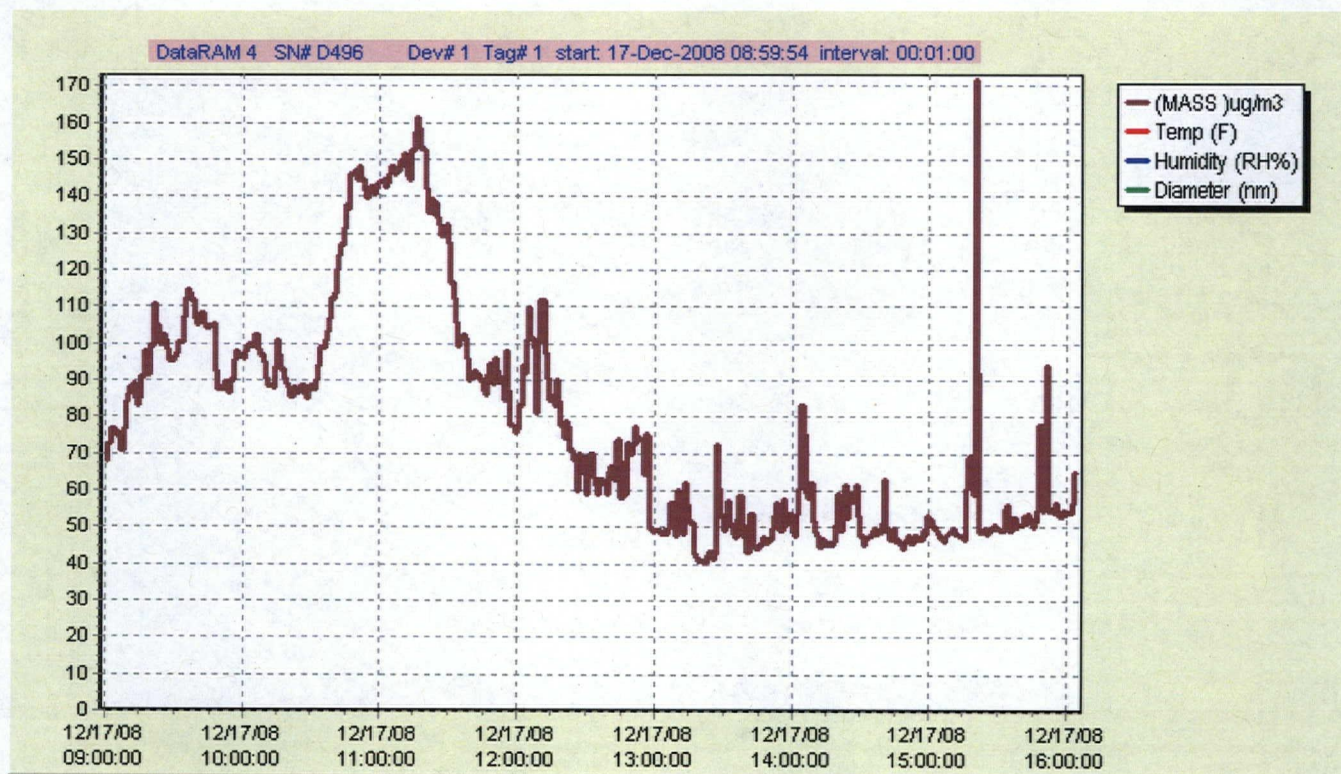
**TOTAL PARTICULATE MATTER DATA  
JEWETT WHITE LEAD COMPANY SITE  
DECEMBER 17, 2008**

RST 2 also monitored for particulates using a DataRAM4 at the edge of each test pit. Results are shown in Attachment C. The results for December 17, when the weather was rain and freezing rain, show how the water in the atmosphere increased the total particulate matter readings. This is likely due to the mechanism by which the total particulate matter is measured (light scattering). The results for December 18, when there was no rain, show two spikes of elevated particulate matter readings. The first of these occurred when the backhoe broke a concrete slab, creating dust, at 07:30. The second spike occurred when the backhoe hit refusal and was scraping concrete, creating dust, at 08:33. However, for both days, it should be noted that a sustained reading above  $300 \mu\text{g}/\text{m}^3$  did not occur. The sustained action level established in the health and safety plan was never exceeded.

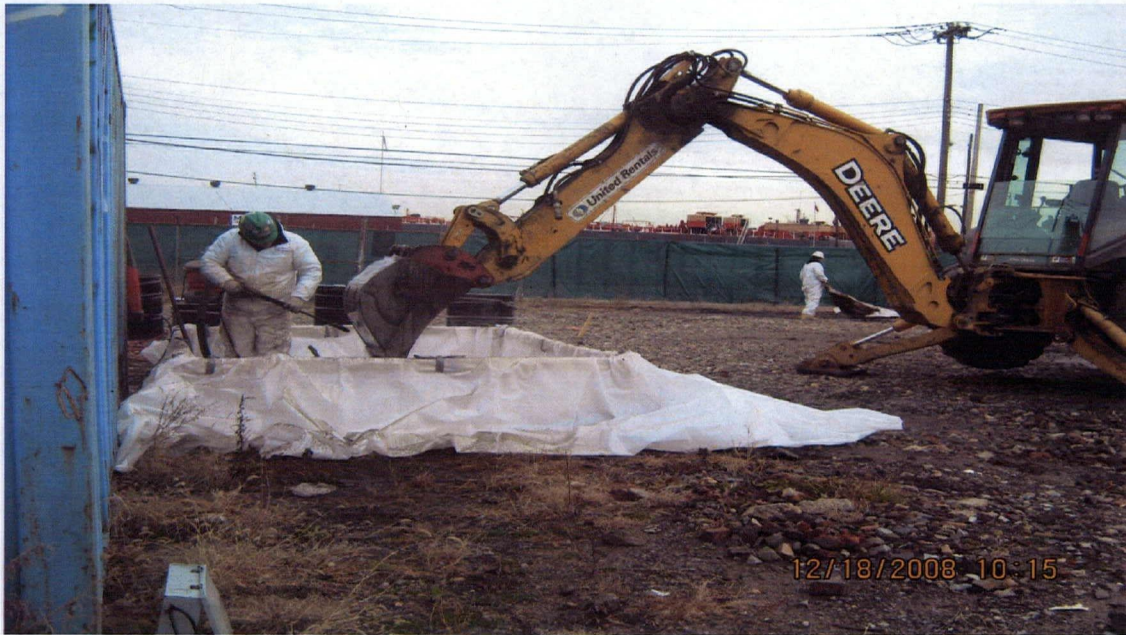
**Picture 1. Decontamination Area.**

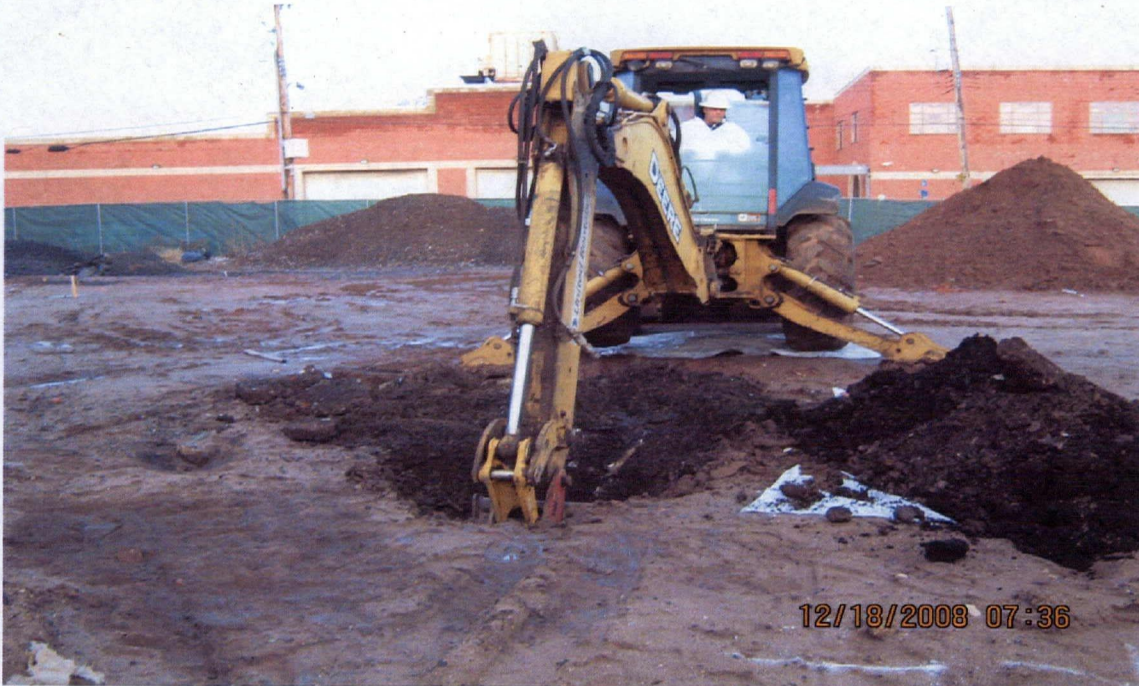
**Picture 2. Typical Test Pit.**

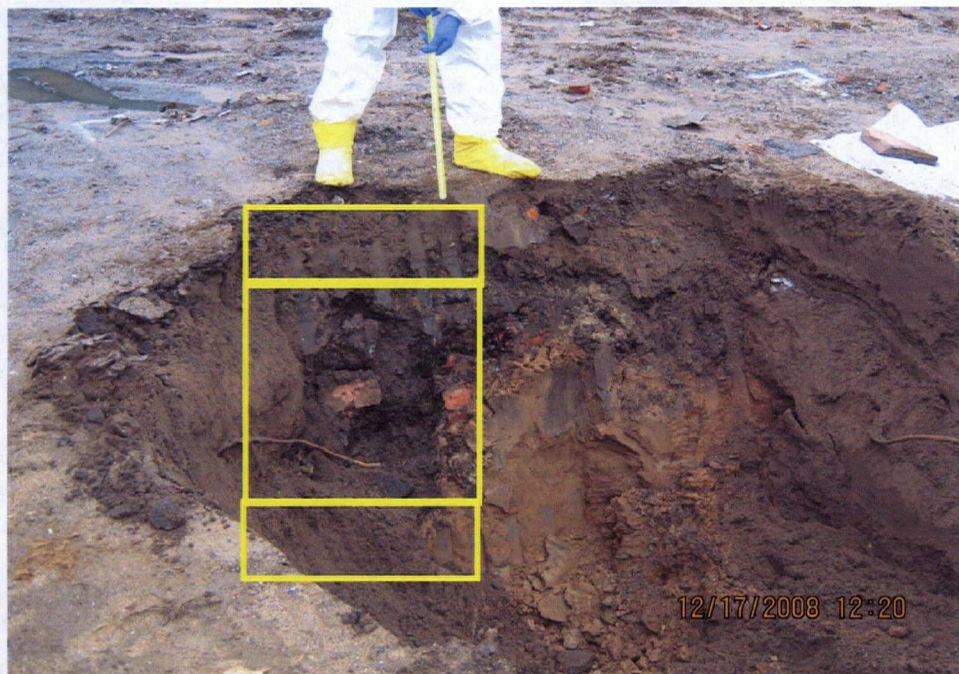
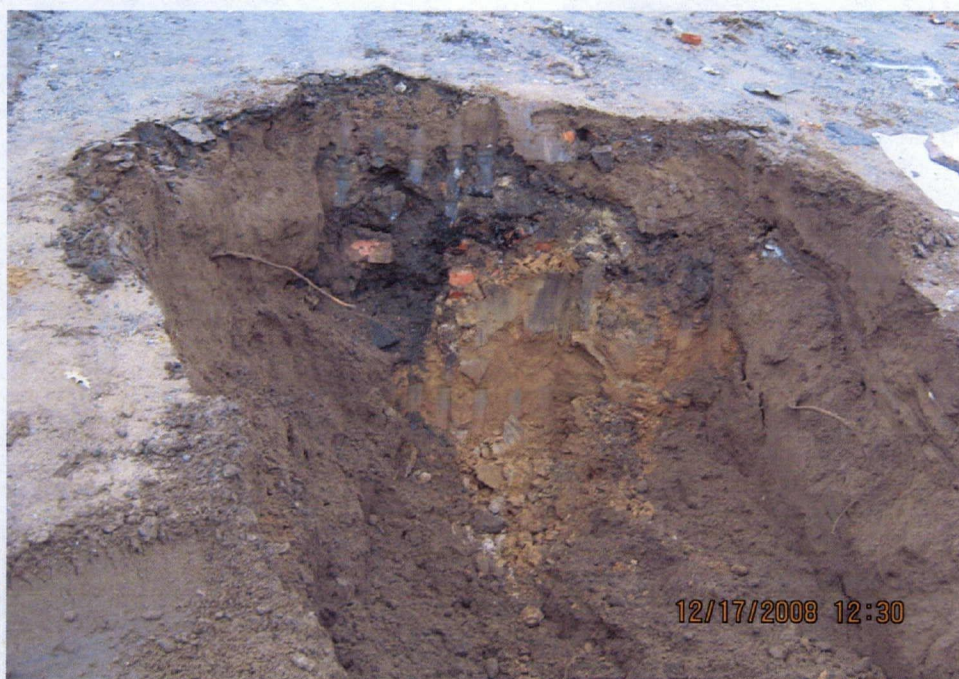
**Picture 3. Test Pit E-1**

0-7"	Black-Brown Sand with gravel and broken brick and concrete
7"-35"	Black sandy fill with brick and debris
35"-58"	Tan, sandy clay

**Picture 4. Closer view of Test Pit E-1**

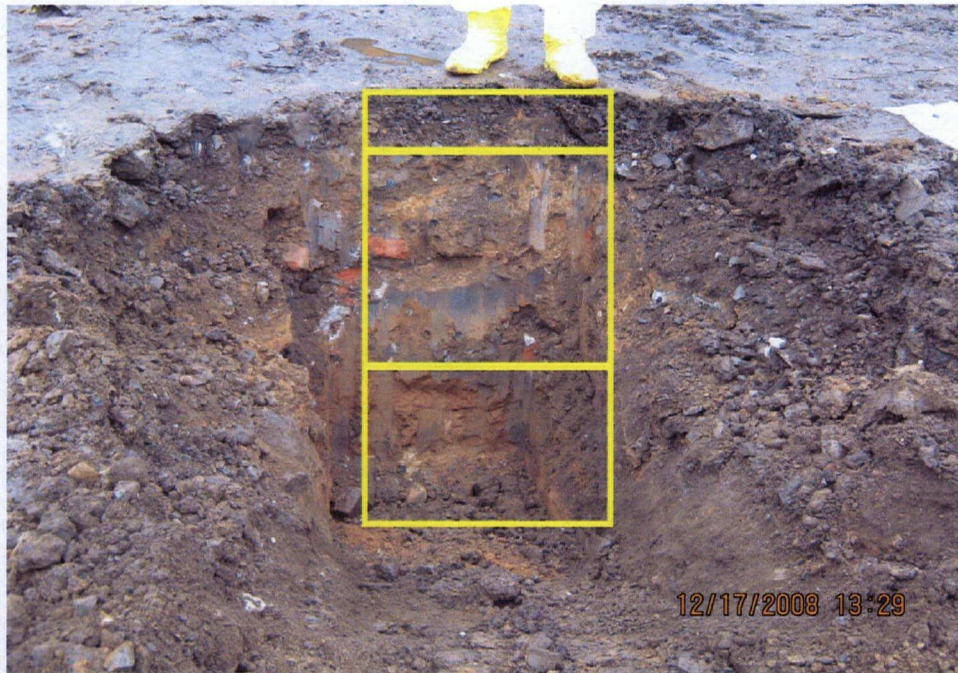
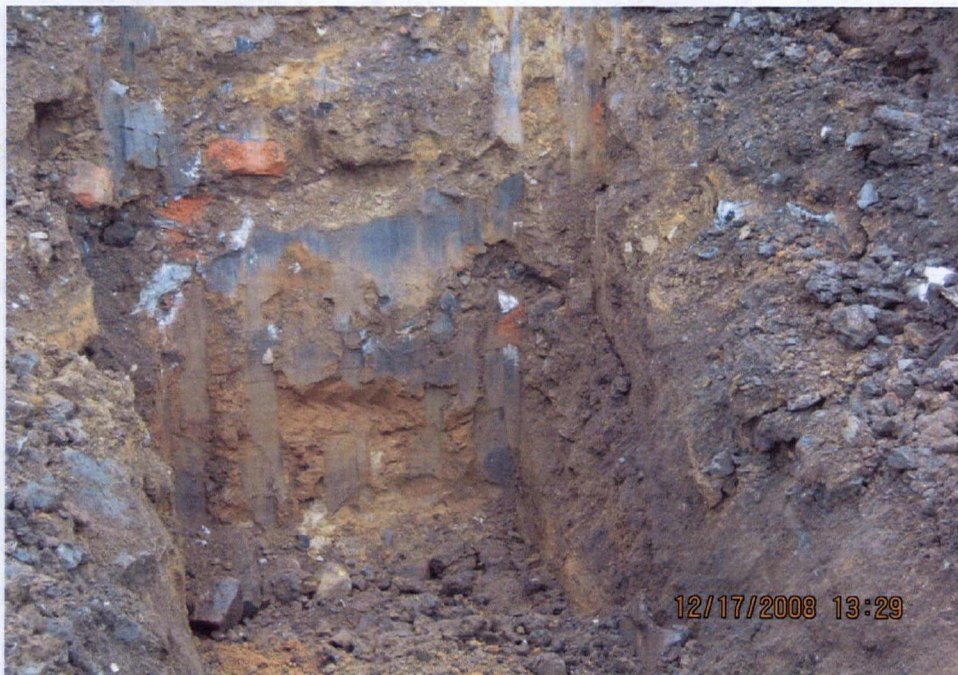
**Picture 5. Test Pit E-2**

0-7"	Charcoal; black/brown sandy clay; concrete chunks
7"-28"	Tan, sandy clay; brick concrete chunks, black gravel
28"-58"	Tan sandy clay, some black mottles

**Picture 6. Closer view of Test Pit E-2**

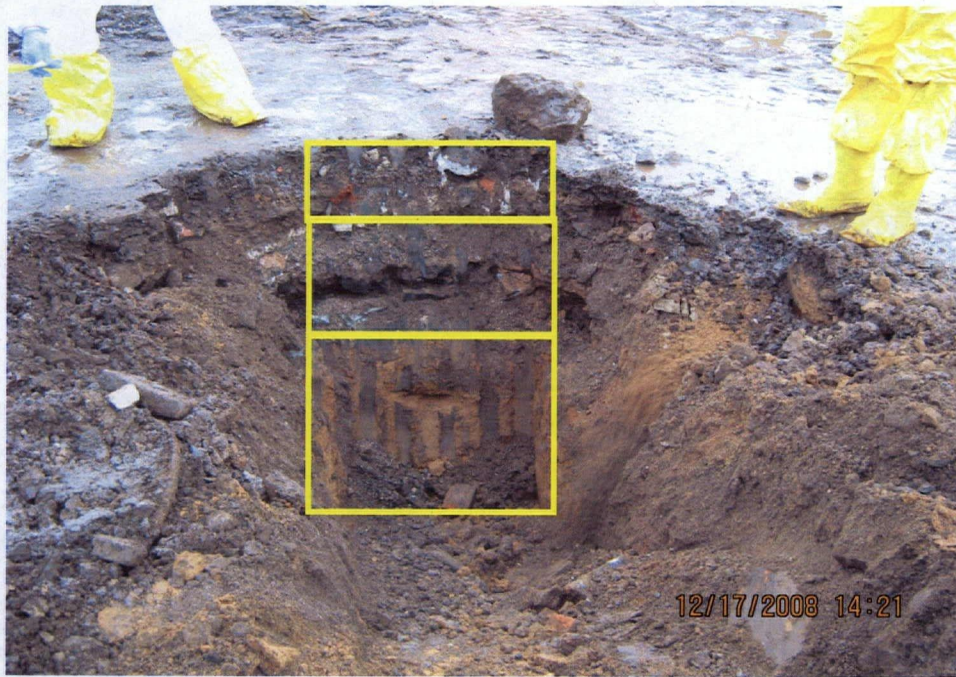
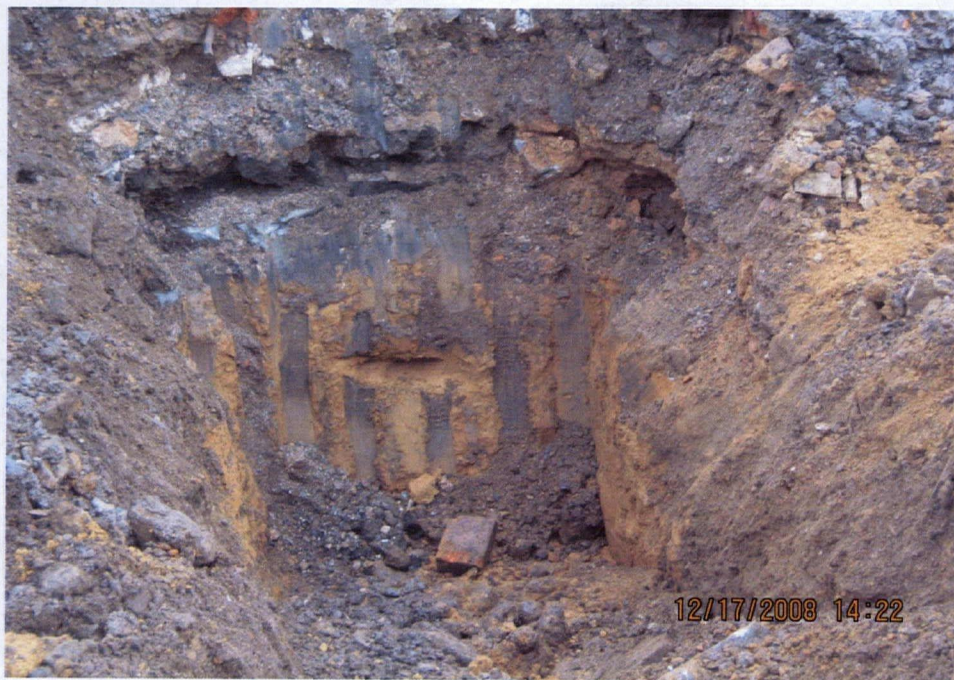
**Picture 7. Test Pit D-1**

0-10"	Black/gray clay fill with asphalt, gravel, concrete, stones and brick
10"-31"	Black asphalt, broken chunks concrete mixed with black sand, brick
31"-48"	Tan, sandy clay, some black mottles

**Picture 8. Closer view of Test Pit D-1**

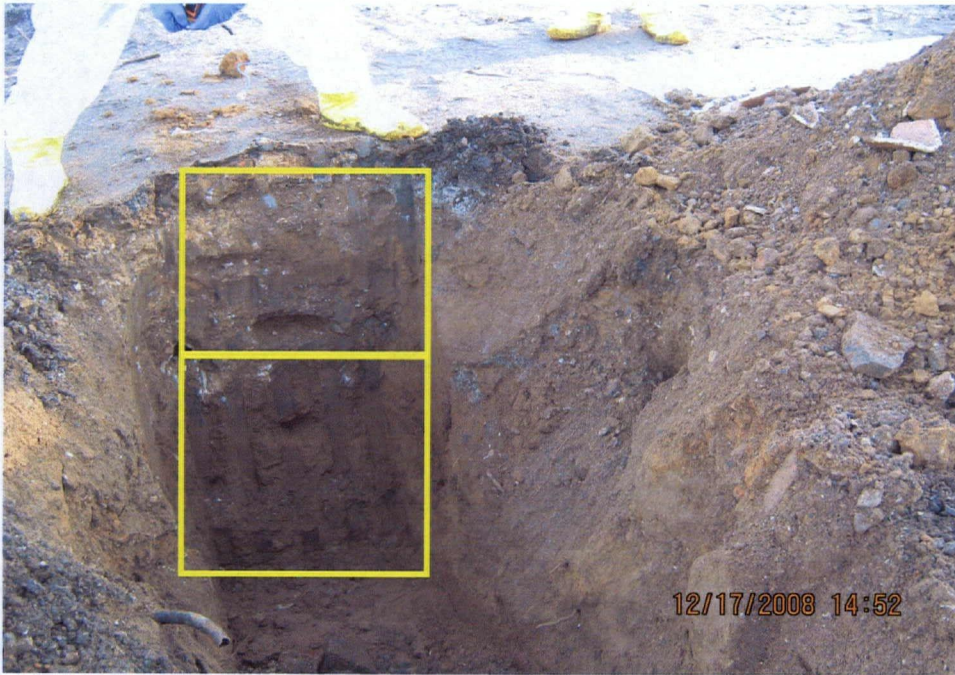
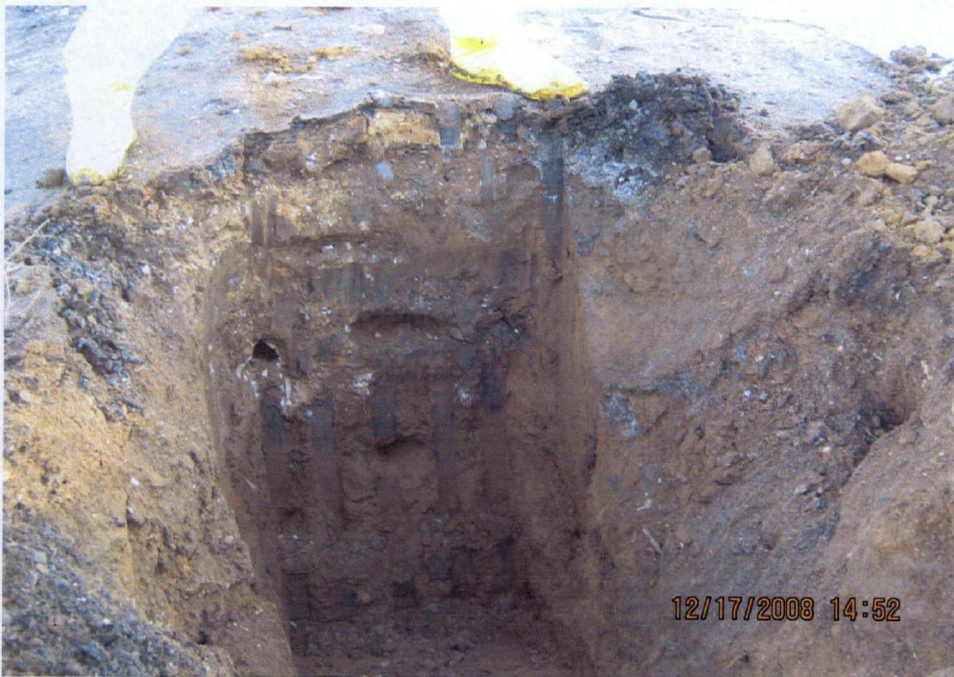
**Picture 9. Test Pit D-2**

0-20"	Dark brown clay, some debris, clay pipe, plastic pipe, brick, chunks of stone, concrete
20"-48"	Tan, sandy clay, some black streaks

**Picture 10. Closer view of Test Pit D-2**

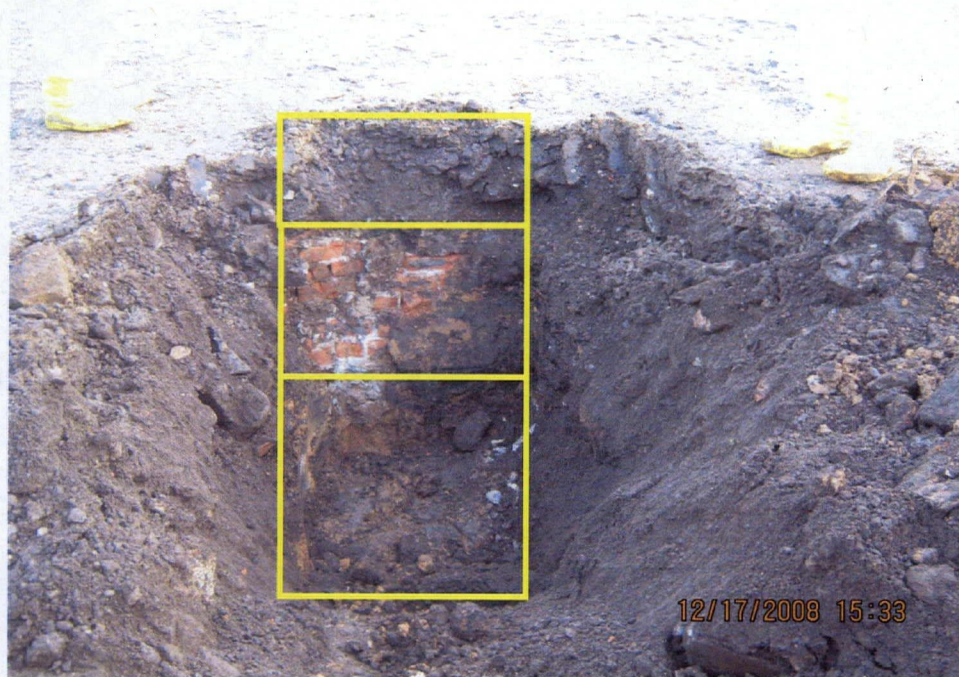
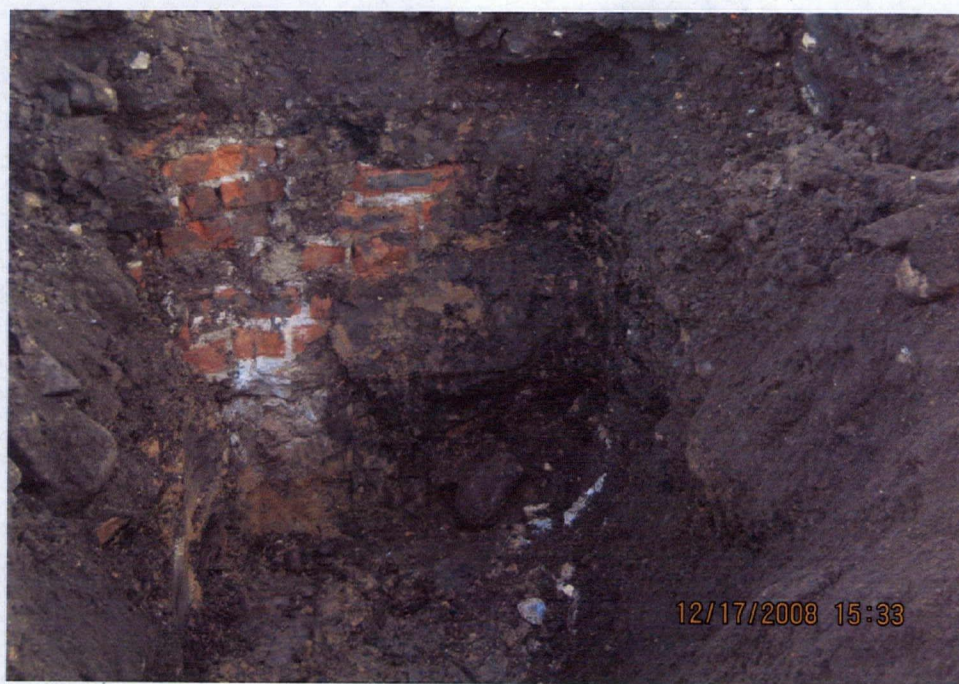
**Picture 11. Test Pit C-1**

0-15"	Sandy black clay with gravel, debris, concrete chunks, brick
15"-33"	Brick wall and tan sand/clay
33"-48"	Tan sandy clay, some black spotting and streaking

**Picture 12, Closer view of C-1**

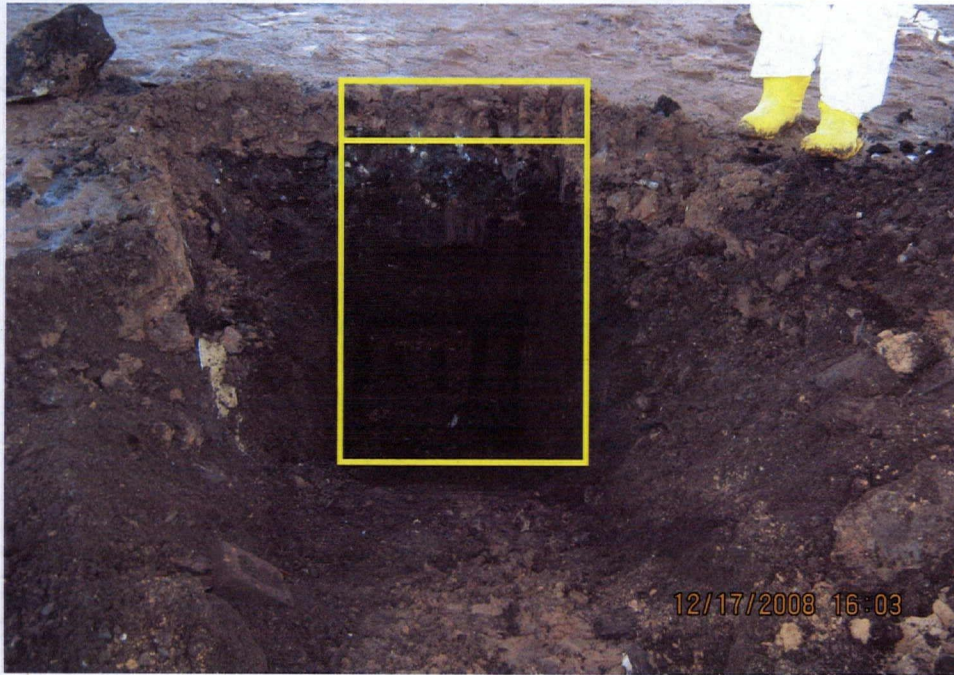
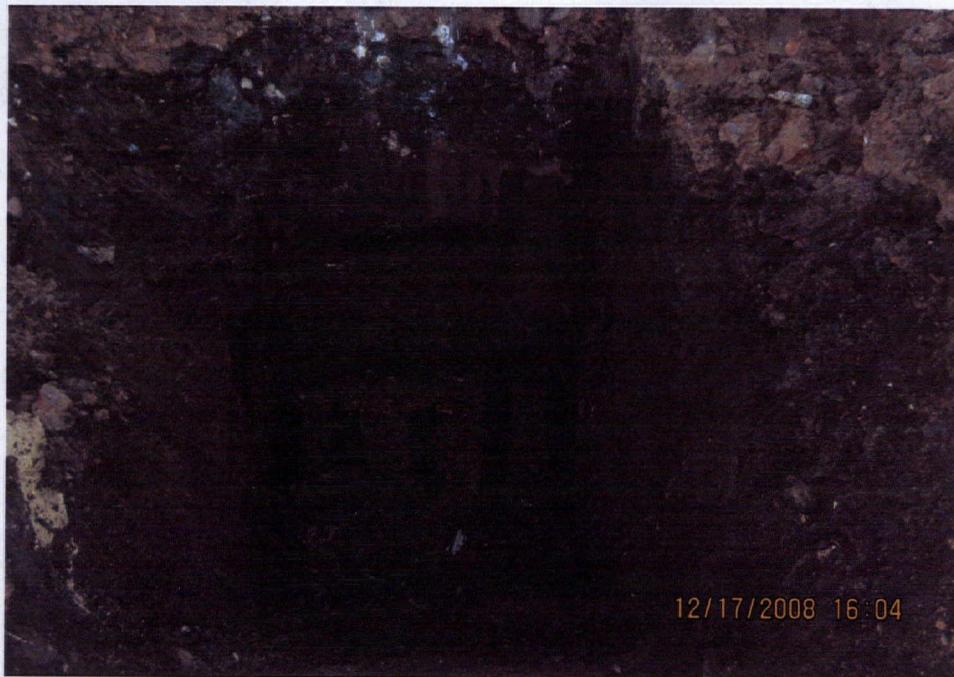
**Picture 13. Test Pit C-2**

0-7"	Brown, sandy clay with gravel, broken concrete
7"-48"	Black burnt wood with roots, wood chunks, brick, metal, broken glass

**Picture 14. Closer view of Test Pit C-2**

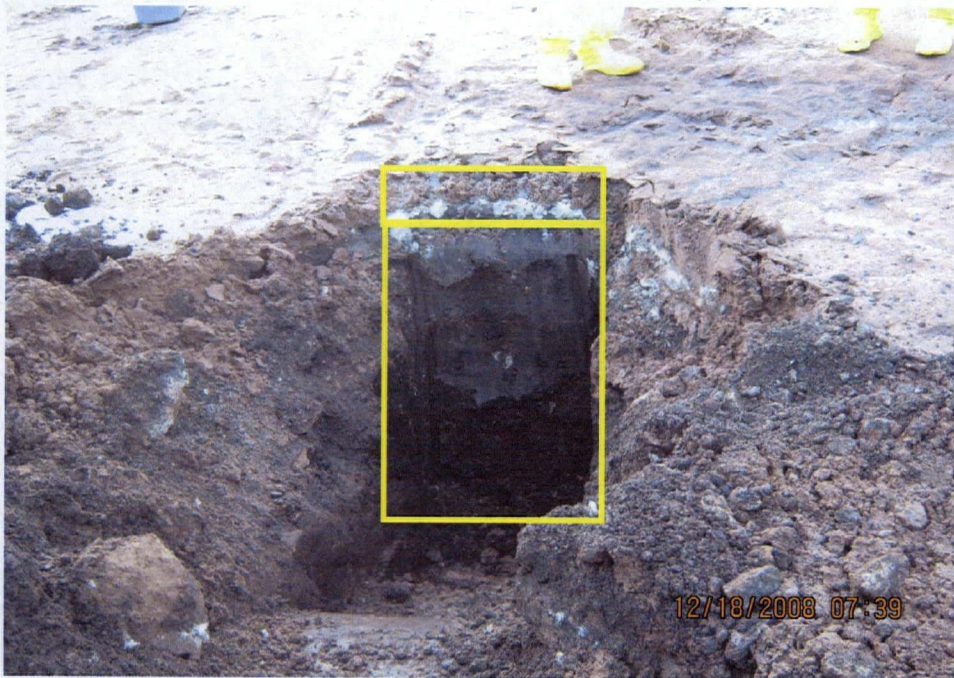
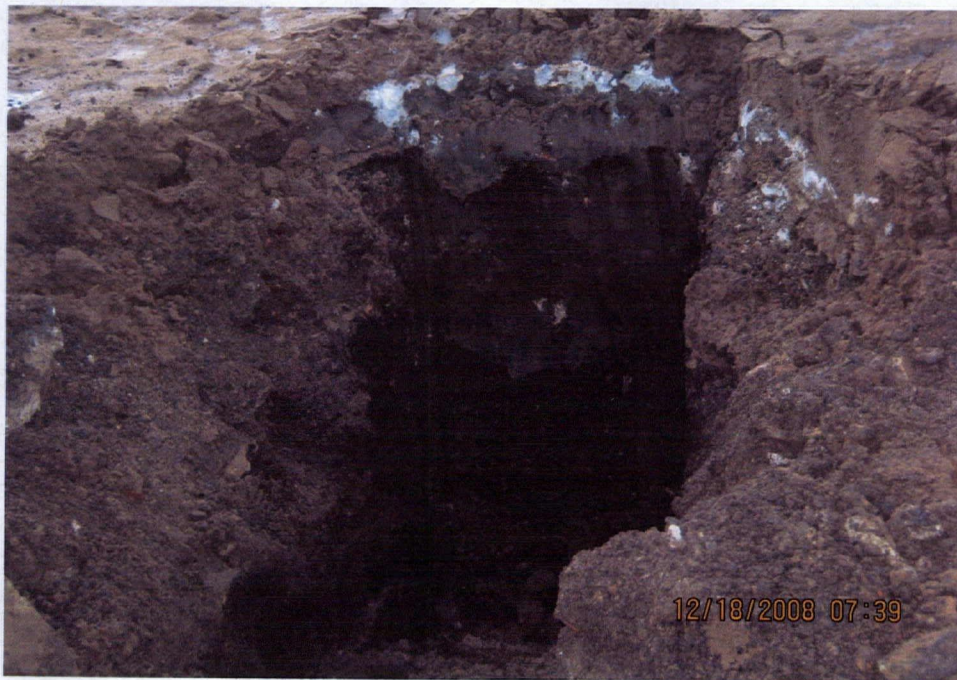
**Picture 15. Test Pit C-3**

0-6"	Cement slab, several broken pieces
6"-48"	Gray/black sandy clay with broken concrete, some gravel, black charred wood and asphalt

**Picture 16. Closer view of Test Pit C-3**

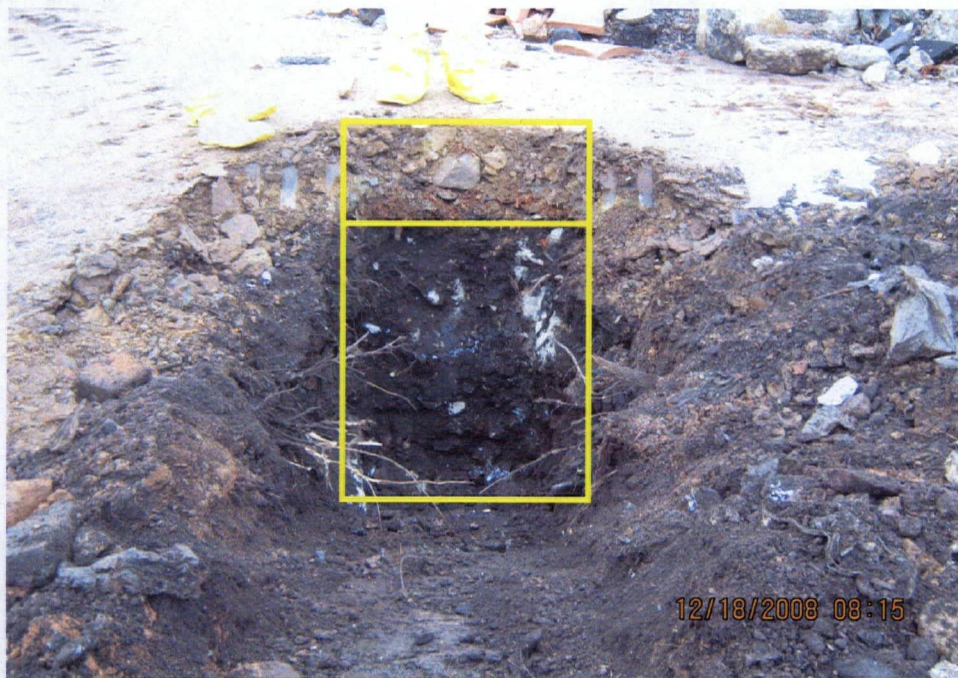
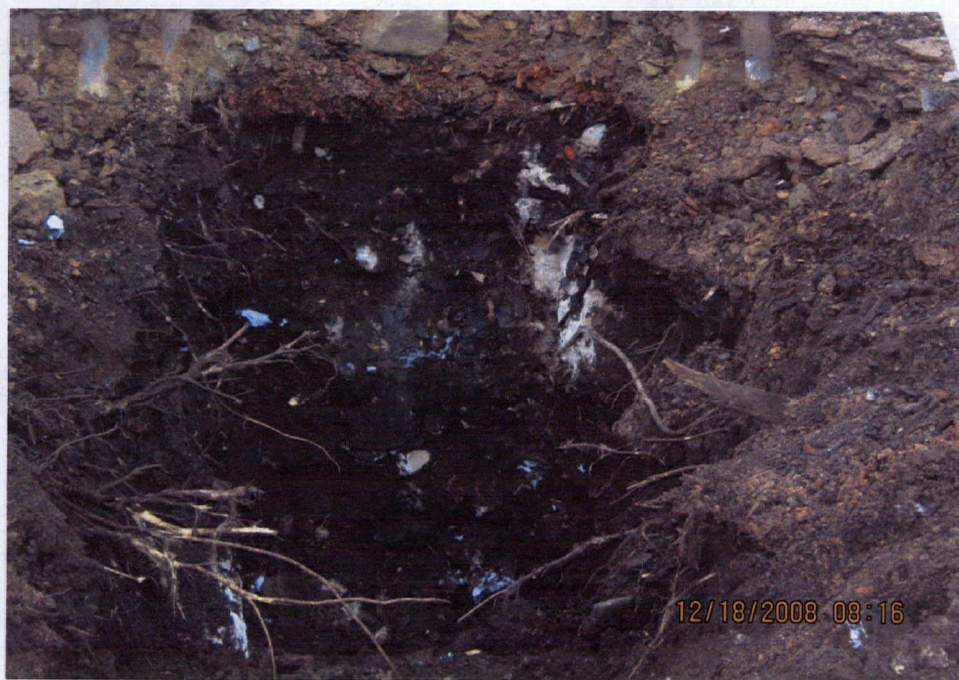
**Picture 17. Test Pit B-4**

0-12"	Brown, sandy clay with wood chips, cobble and stones
12"-48"	Black loamy soil, decomposed wood, broken concrete, styrofoam, broken brick, roots at 15" bgs, broken wood

**Picture 18. Closer view of Test Pit B-4**

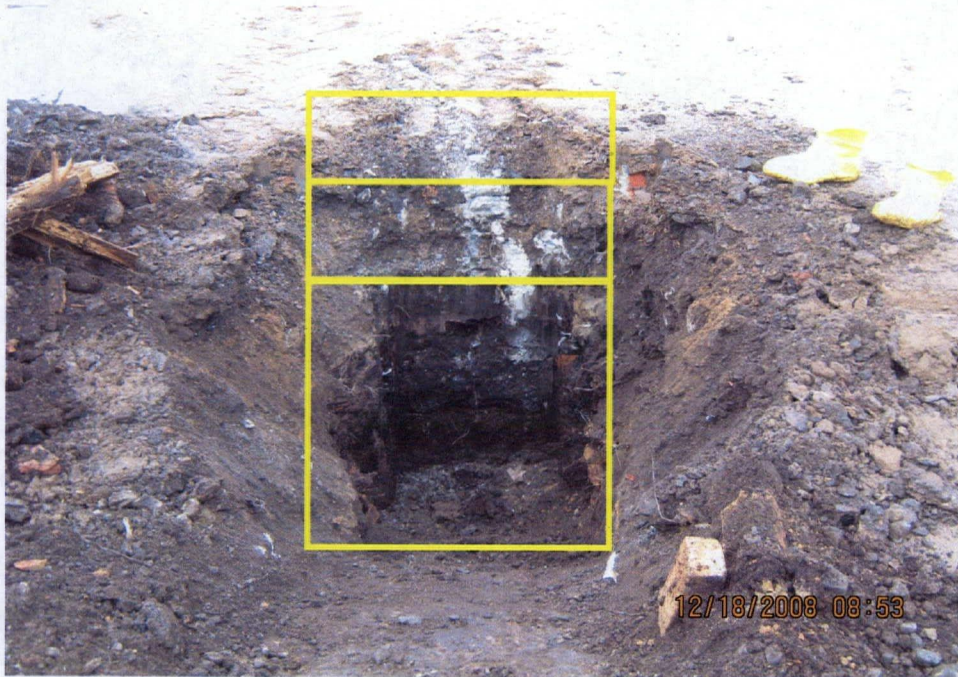
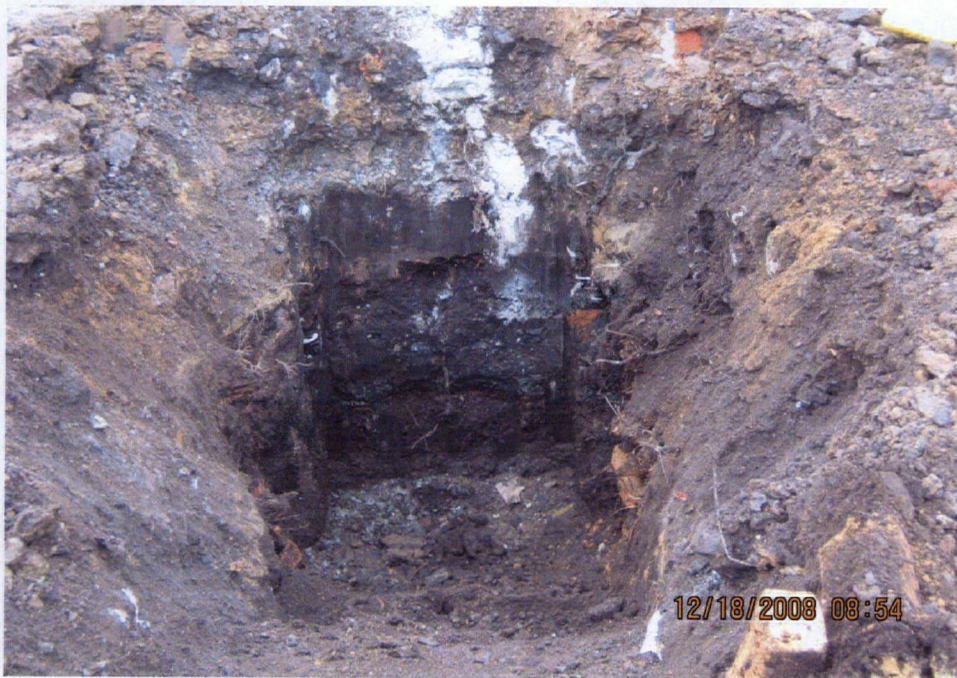
**Picture 19. Test Pit B-3**

0-9"	Brown, sandy clay with gray gravel, large concrete chunk located in one spot in middle
9"-18"	Gray to dark gray gravel and broken concrete
18"-48"	Black loamy soil, decomposed wood and wood pieces, tan brick, concrete and some metal

**Picture 20. Closer view of Test Pit B-3**

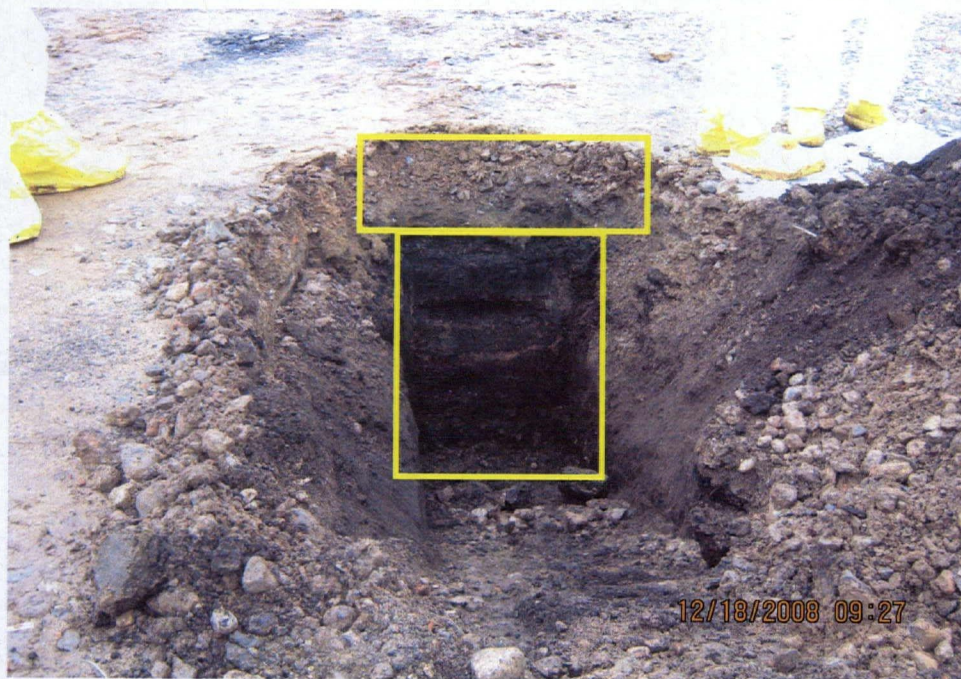
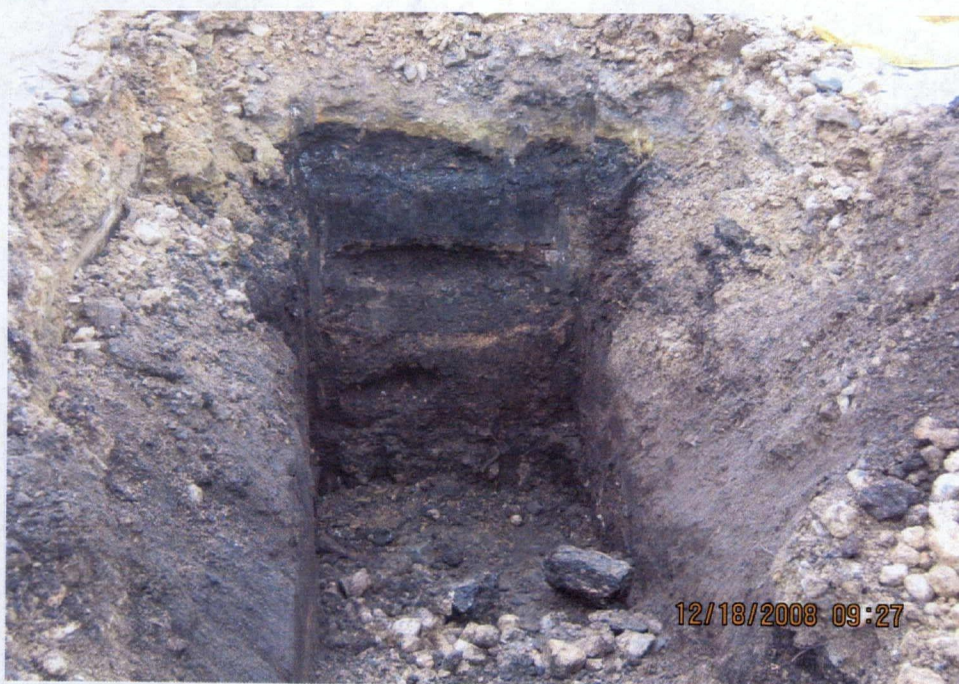
**Picture 21. Test Pit B-2**

0-13"	Brown clayey sand aggregate gravel base, very firm loamy soil
13"-48"	Black loamy soil, decomposed wood and tan clay

**Picture 22. Closer view of Test Pit B-2**

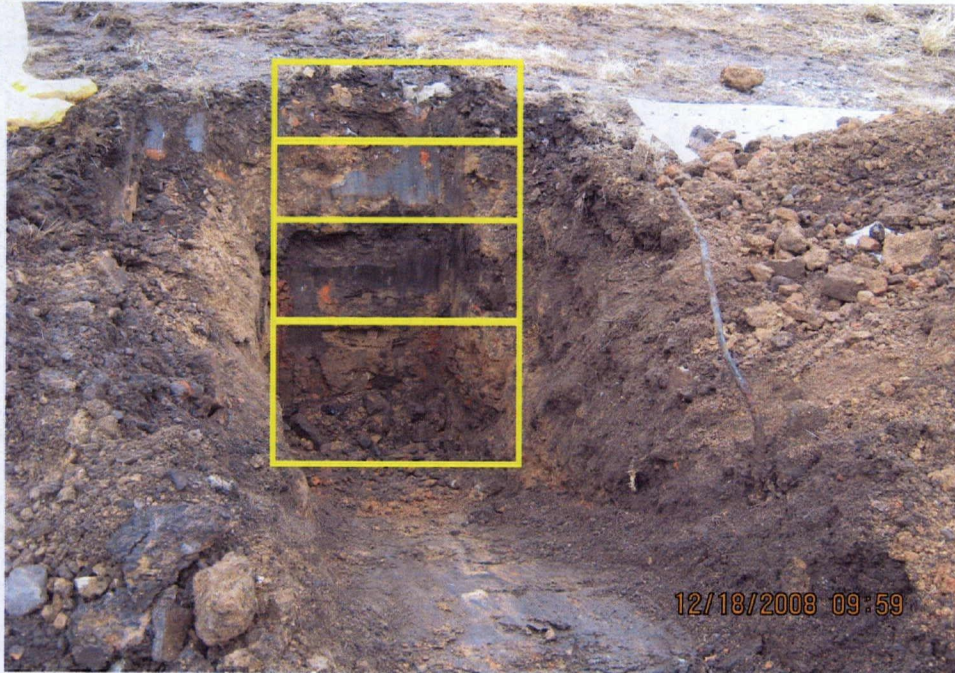
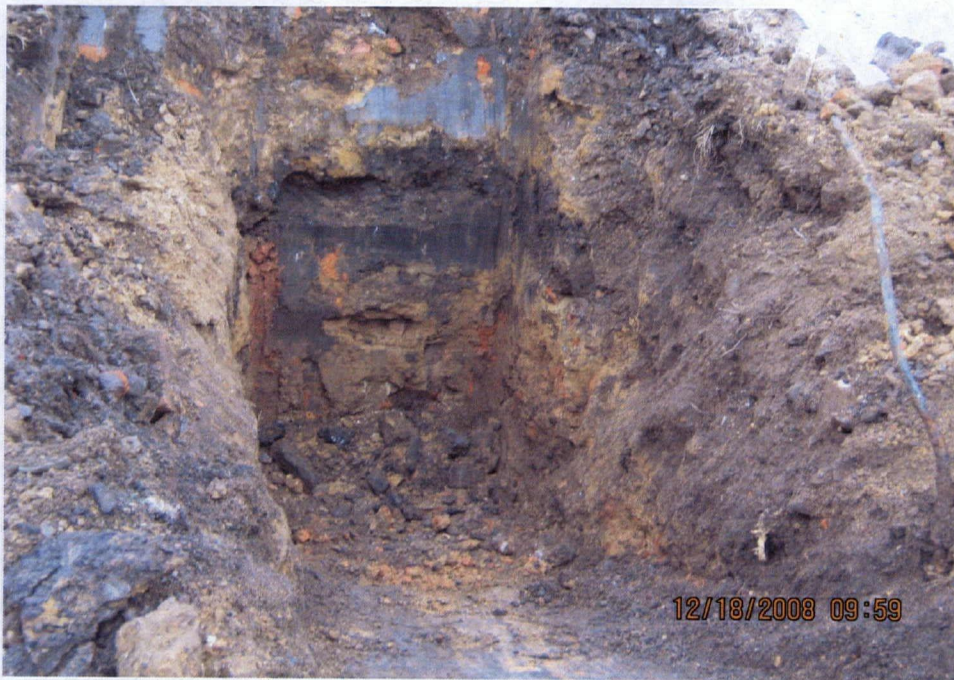
**Picture 23. Test Pit B-1**

0-5"	Black clay loam with gravel
5"-19"	Light tan clay with bricks
19"-35"	Brown-black clay with bricks and broken stones
35"-48"	Light tan clay with some red and yellow brick

**Picture 24. Closer view of Test Pit B-1**

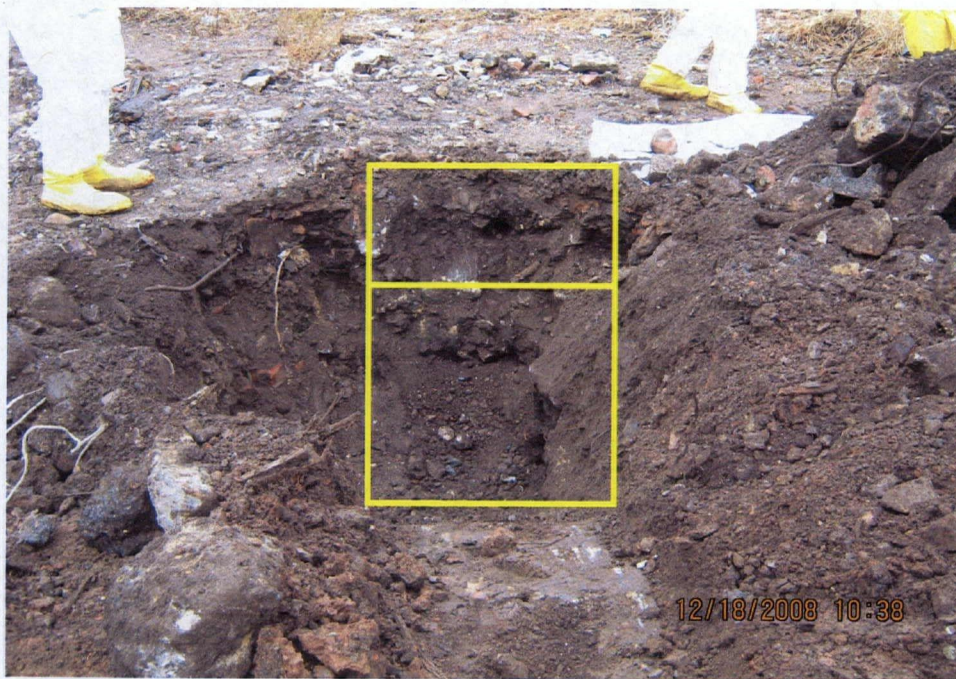
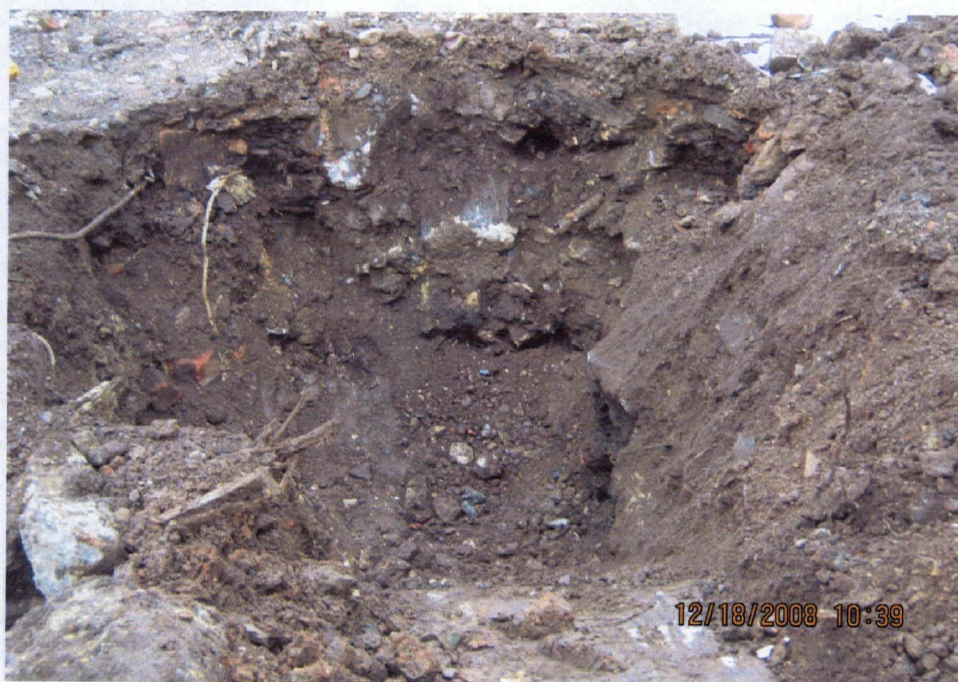
**Picture 25. Test Pit A-5**

0-18"	Black clay and sand, concrete and brick, some metal rebar and wire
18"-42"	Broken concrete and brick and broken pottery mixed with black loamy soil
42"	Refusal, buried concrete slab

**Picture 26. Closer view of Test Pit A-5**
